## **Assessment of Dam Safety of Coal Combustion Surface Impoundments**

**Indianapolis Power & Light Company**

**Harding Street Generating Station**

**June 4, 2010**

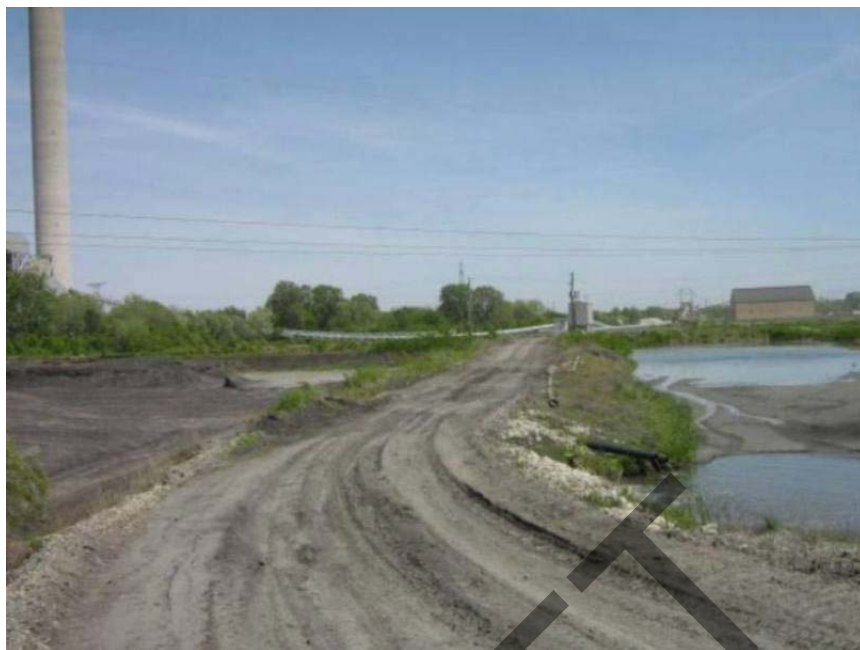
The crest of Ash Pond 1 appeared to be in satisfactory condition (Photographs 1, 8, 11, and 12). The crest was approximately 15 feet wide with the exception of the haul road portion of the crest on the north embankment that was approximately 20 feet wide. The entire crest is exposed to vehicle traffic. Depressions and minor ruts, apparently due to vehicle traffic, were observed on the crest of each embankment (Photograph 1, 8 and 12). The crest surface appears to consist of compacted granular soils. A section of the crest of the south embankment has been excavated and remains open, apparently to facilitate the repair of a joint on the cinder pit sluice line (Photograph 5).

1. Ash Pond 1 - South Embankment Crest, Looking East

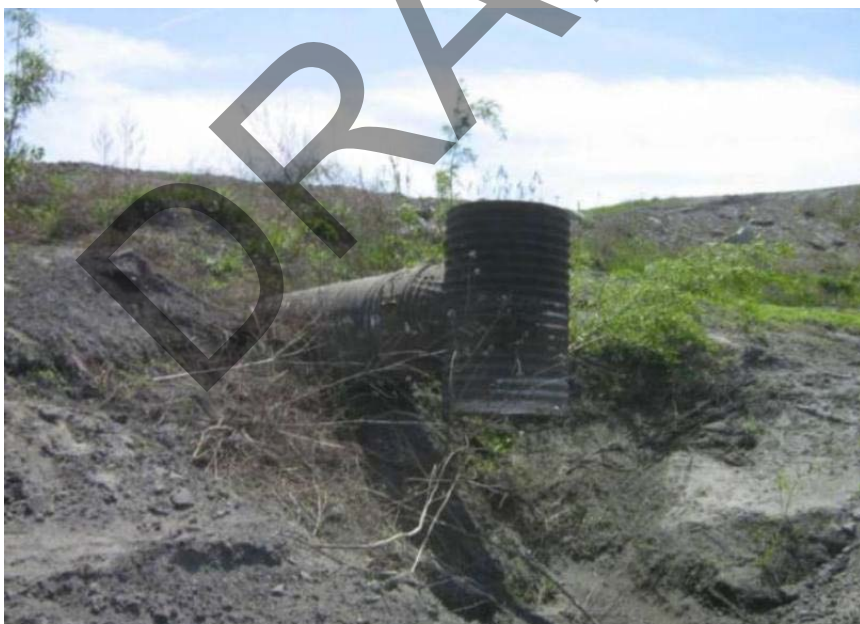
The outlet pipe in Ash Pond 1 appears to be in good condition. A 30-inch-diameter CMP tee is located at the southwestern end of the pond, connecting the pond with Ash Pond 2A (Photograph 2). No unusual movement was observed around the pipe penetration.

2. Ash Pond 1 - Inlet from Ash Pond 2A (30-inch-diameter CMP), Located at South Embankment Interior Slope

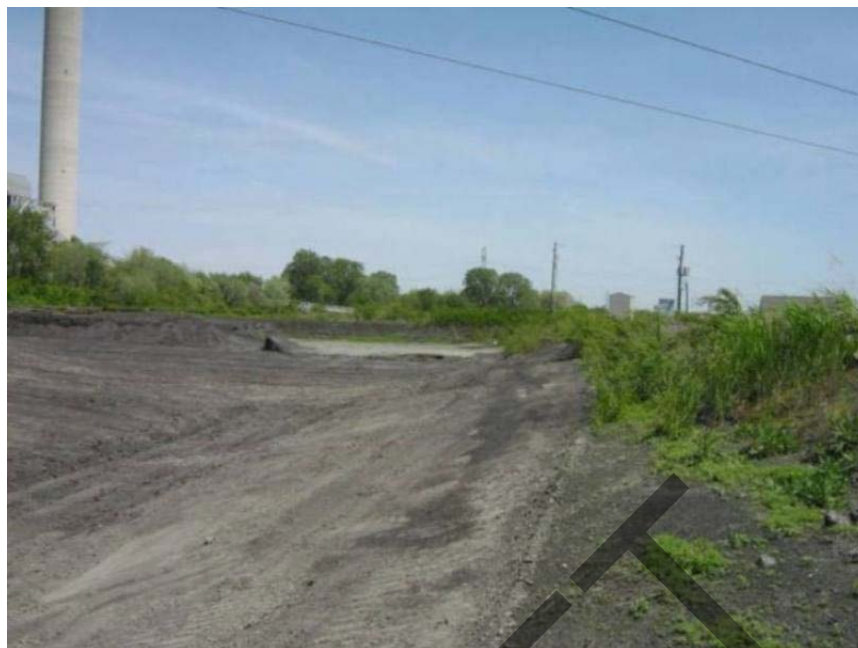
3. Ash Pond 1 - South Embankment Interior Slope, Looking East

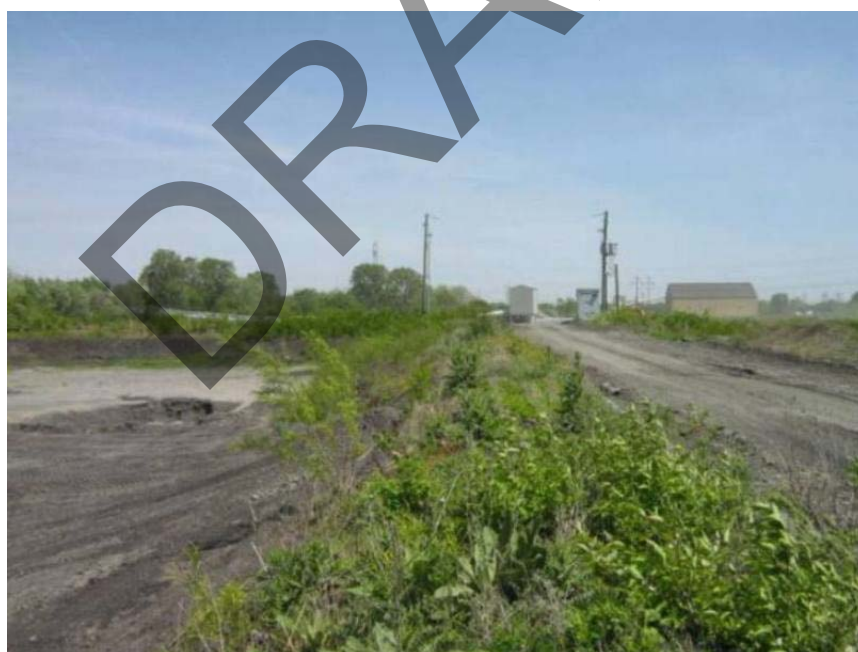
The interior slopes appear to be in fair condition. Light vegetation covers the south and east embankments (Photographs 4 and 9). The interior slopes are approximately 3H:1V. No armoring of the interior slope is present, and much of the pond's interior surface consists of exposed ash. Areas of beaching and erosion were observed on portions of the unprotected slope surface (Photograph 16). Beaching is defined as the progressive erosion of the interior embankment slope caused by repeated wave action

4. Ash Pond 1 - Vegetation on South Embankment Interior Slope,  
Looking East

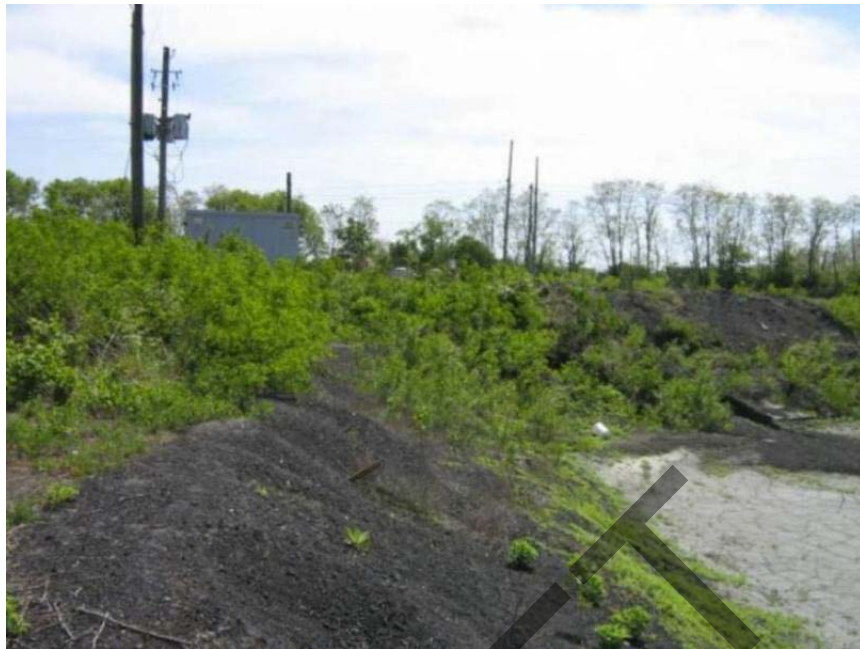
9. Ash Pond 1 - East Embankment Interior Slope, Looking South

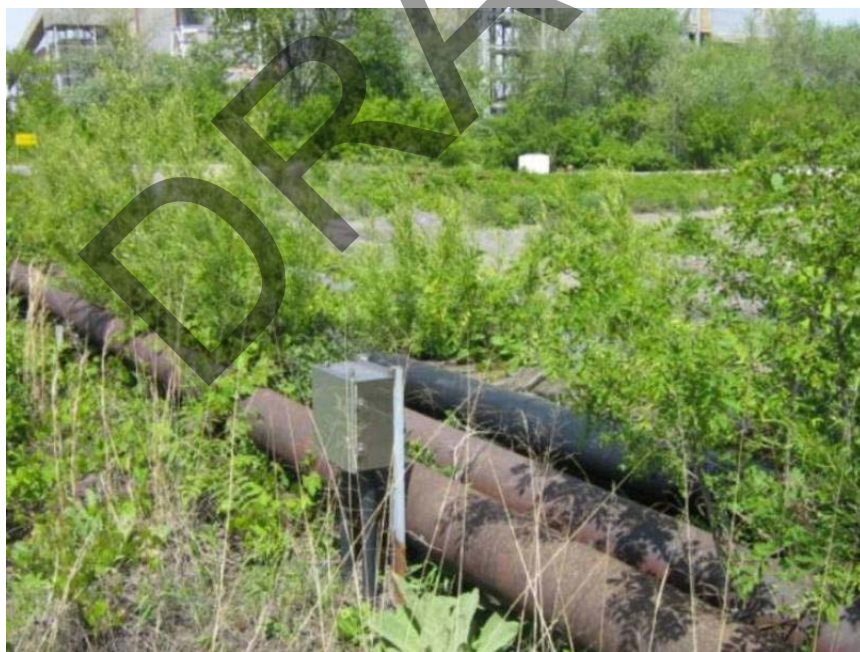
10. Ash Pond 1 - East Embankment Crest with Four (4) 8-inch-Diameter Sluice Lines and Vegetation

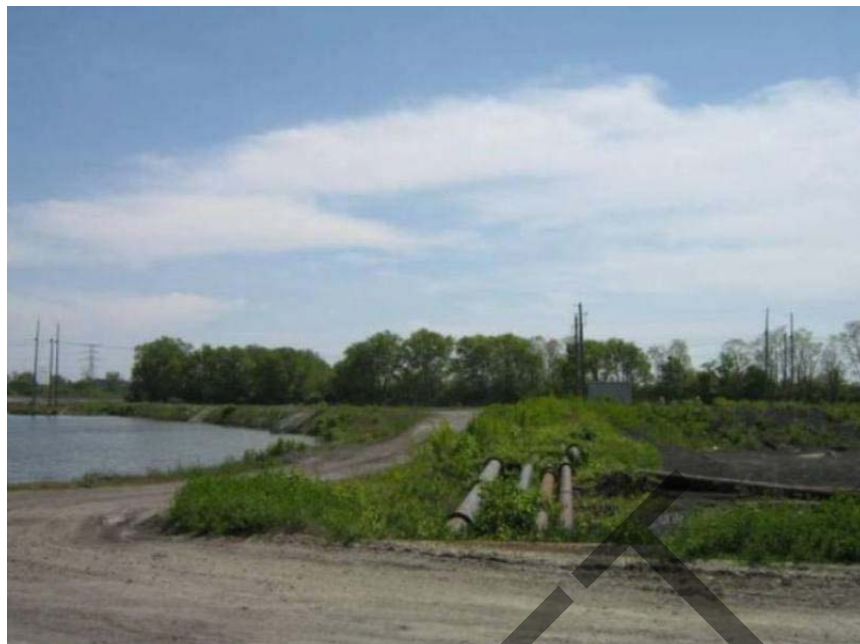
11. Ash Pond 1 - Four (4) 8-inch-Diameter Slice Lines along East Embankment Crest, Looking South

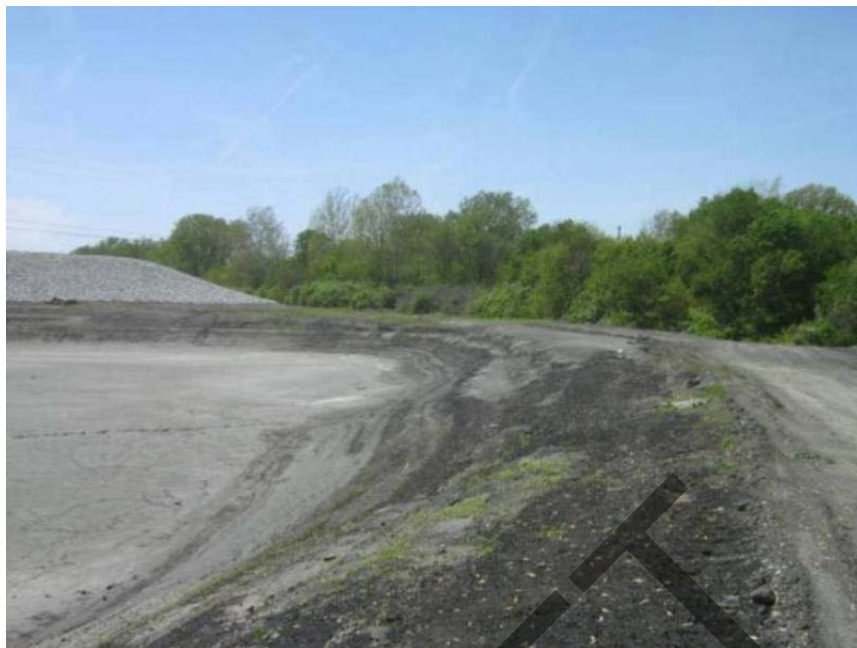
13. Ash Pond 1 - North Embankment Interior Slope, Looking West, Area of Beaching is Visible in Distance

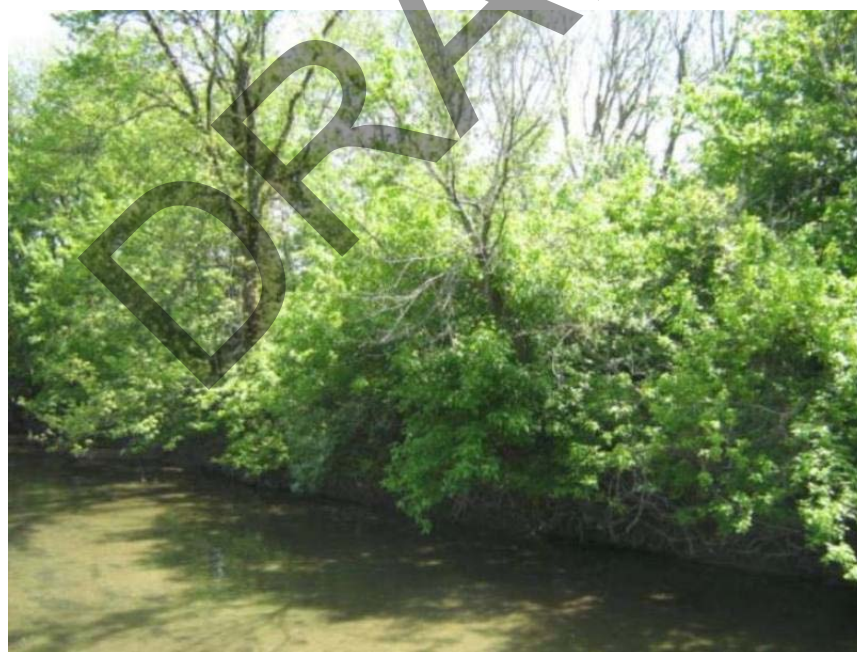
14. Ash Pond 1 - Dense Vegetation along North Embankment Exterior Slope, View from Bridge Over Lick Creek

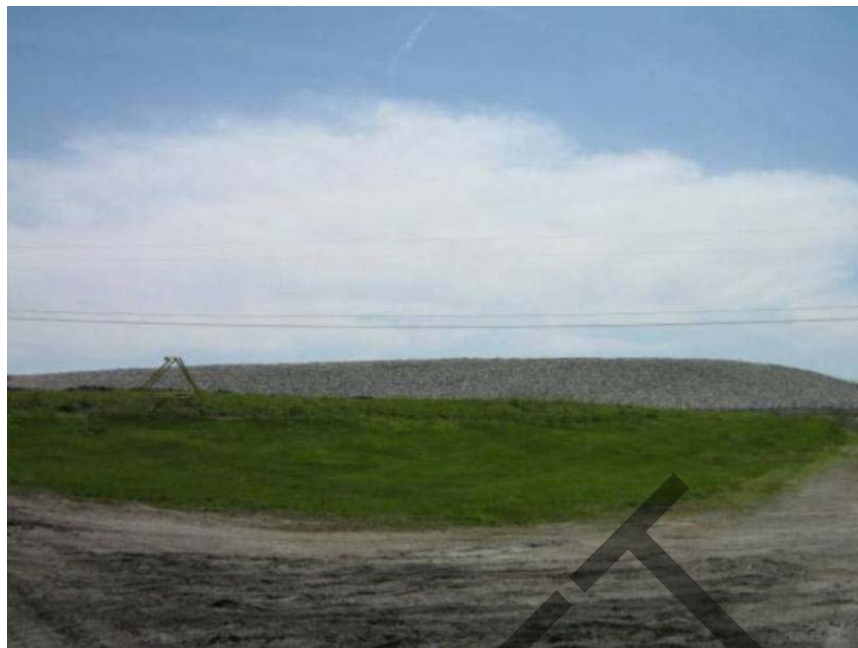
15. Ash Pond 1 - North Embankment Exterior Slope

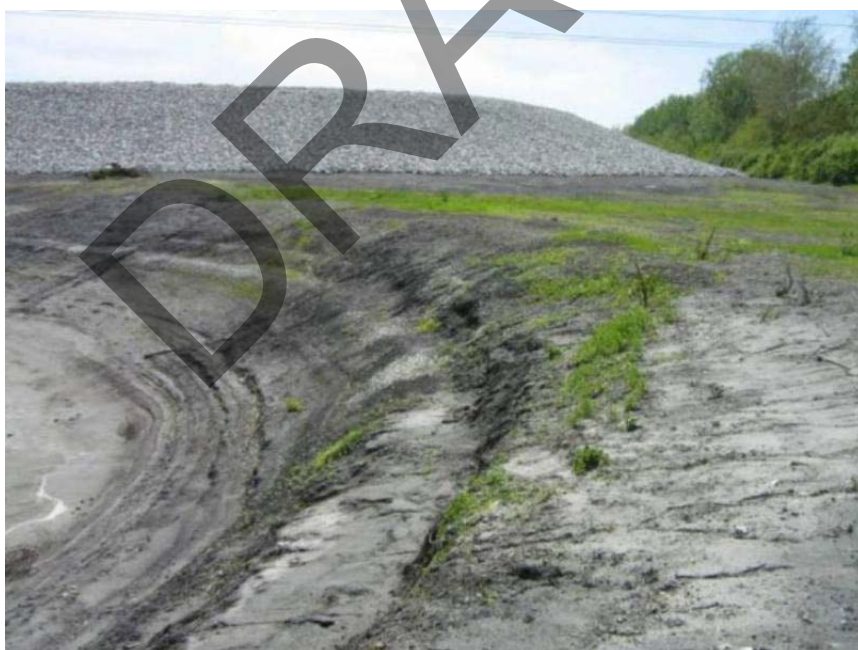
16. Ash Pond 1 - Beaching and Surface Erosion at the top of the North Embankment Interior Slope, Looking West

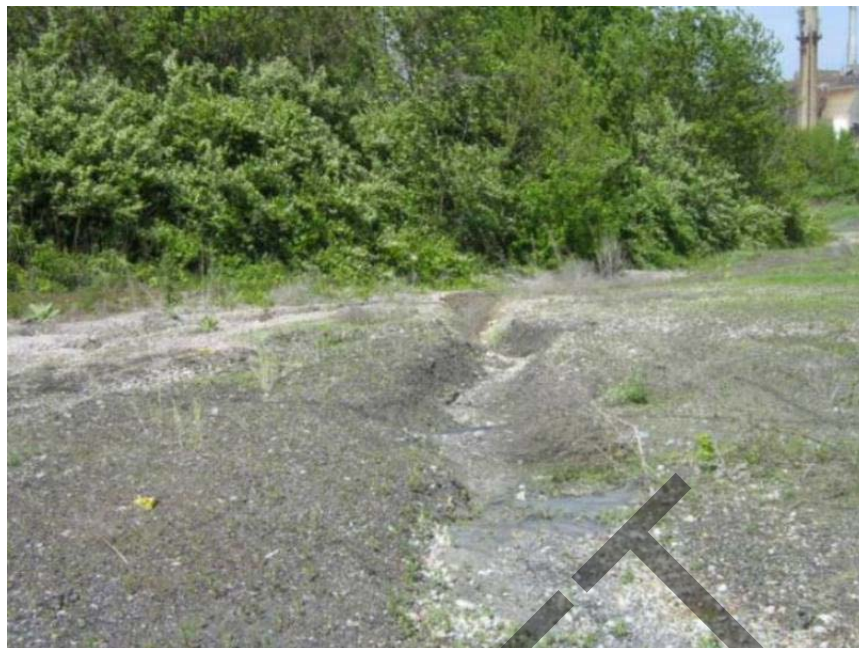
17. Ash Pond 1 - Erosion Rill West of the North Embankment

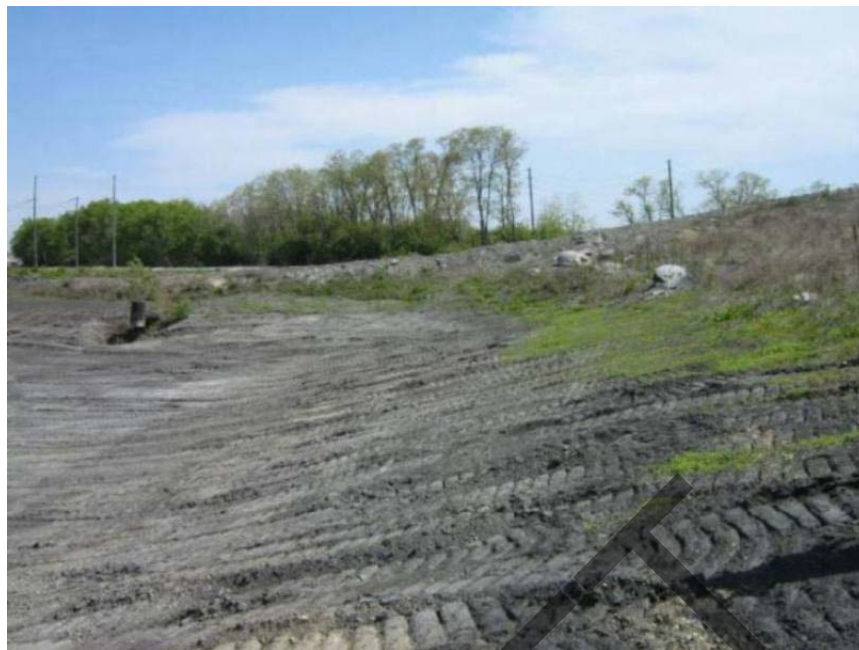
19. Ash Pond 1 - Scarified Surface of West Embankment Interior Slope, Looking South

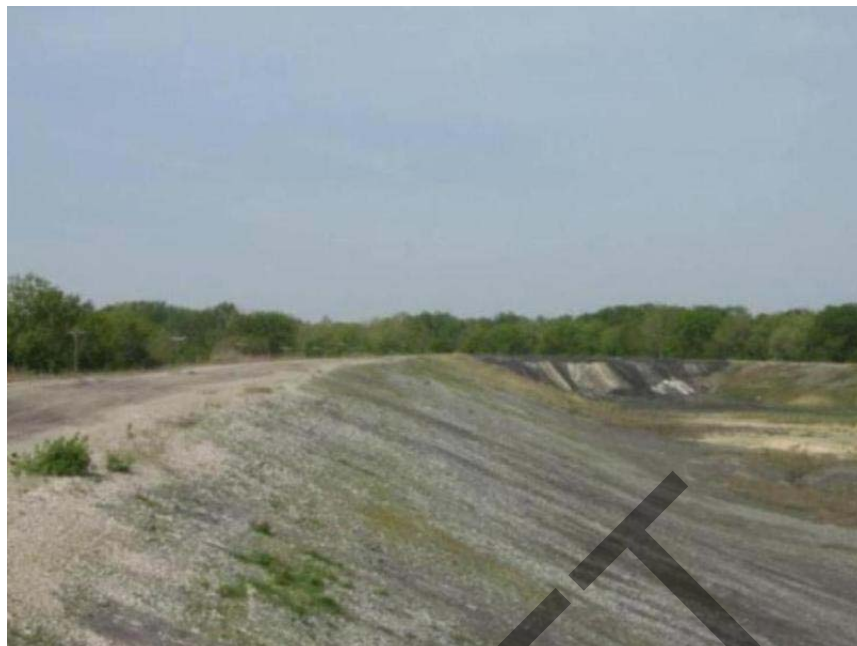
20. Ash Pond 2 - South Embankment Interior Slope, Looking West,  
Sparse Vegetation and Erosion Rills are Visible

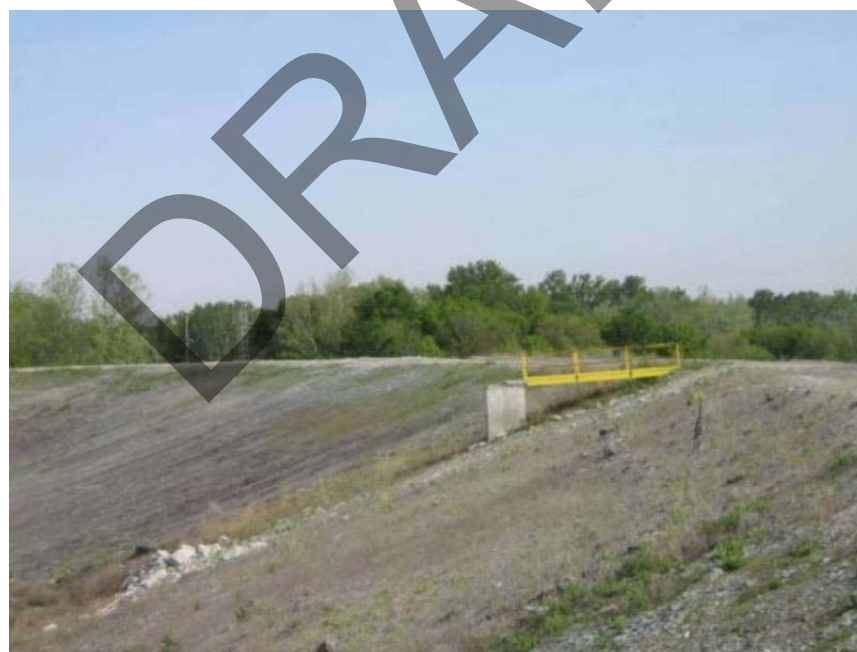
21. Ash Pond 2 - Outlet Structure on East Embankment Interior  
Slope, Looking North

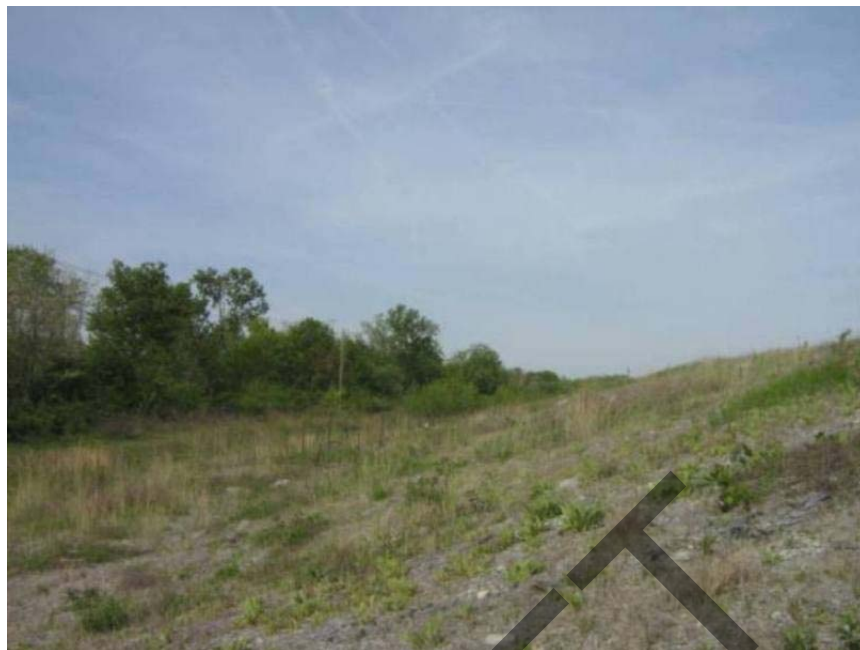
22. Ash Pond 2 - South Embankment Exterior Slope, Looking West

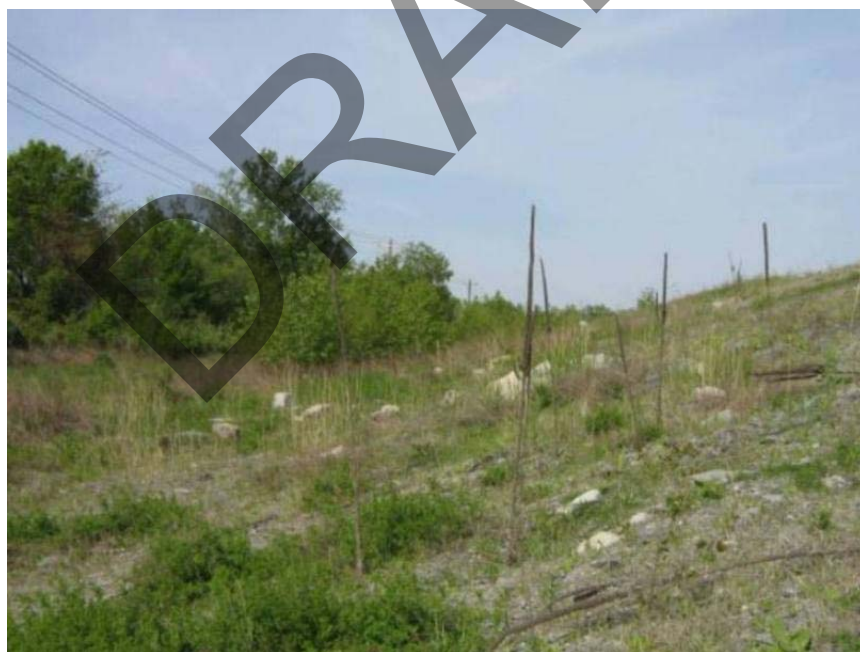
23. Ash Pond 2 - South Embankment Exterior Slope, Looking North, Vegetation Located at on Slope and Toe

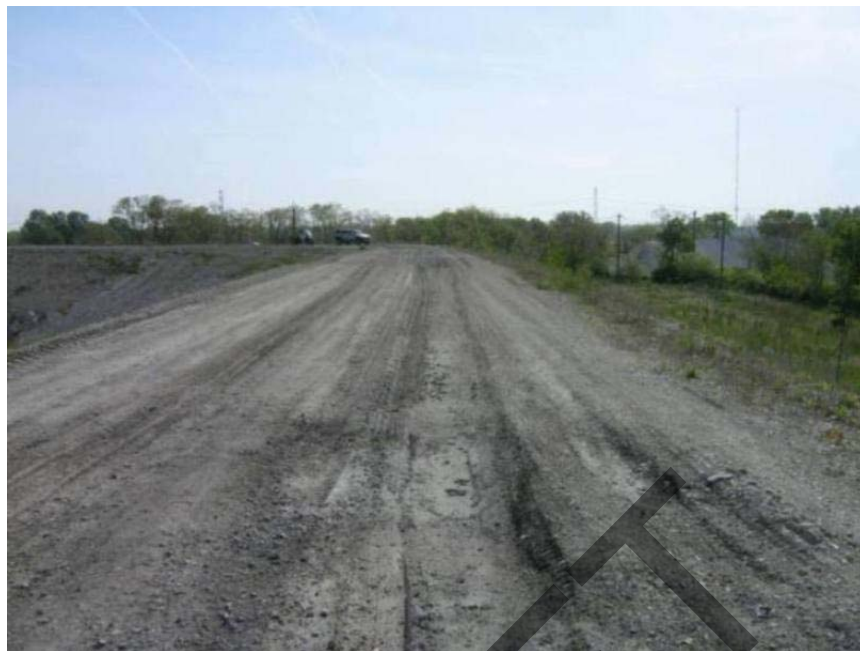
24. Ash Pond 2 - Ruts along South Embankment Crest, Looking East

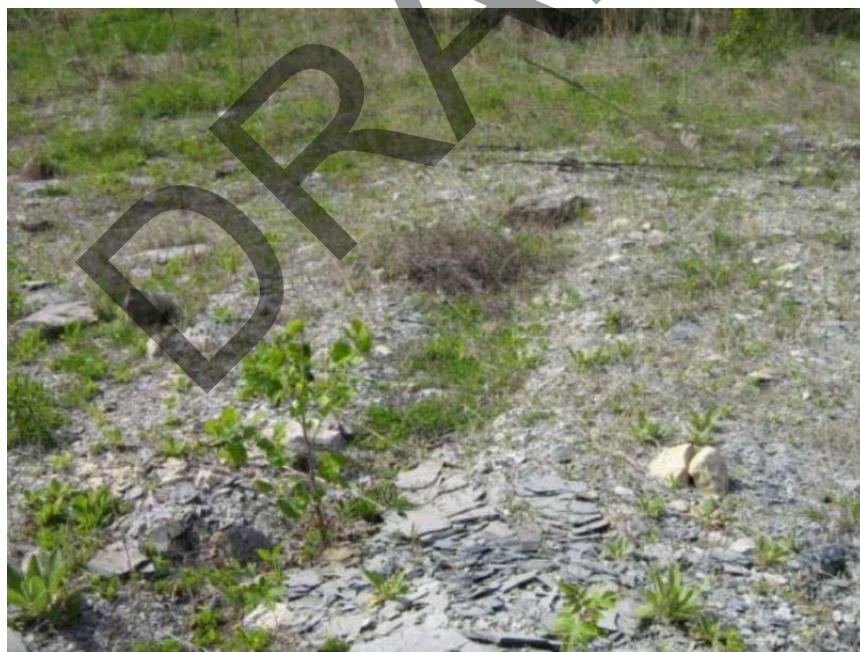
25. Ash Pond 2 - Erosion Rill on South Embankment Exterior Slope

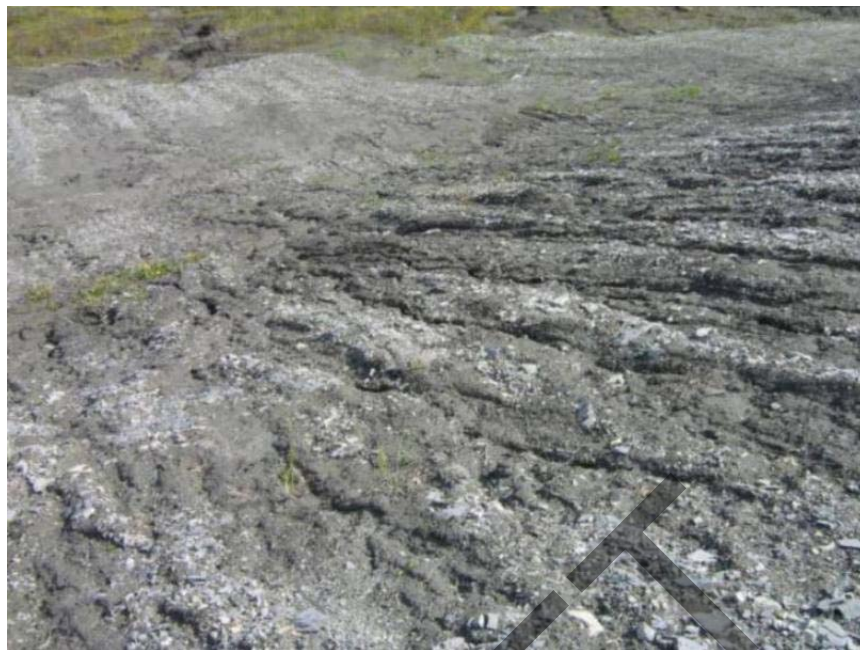
26. Ash Pond 2 - Erosion Rills on South Embankment Interior Slope

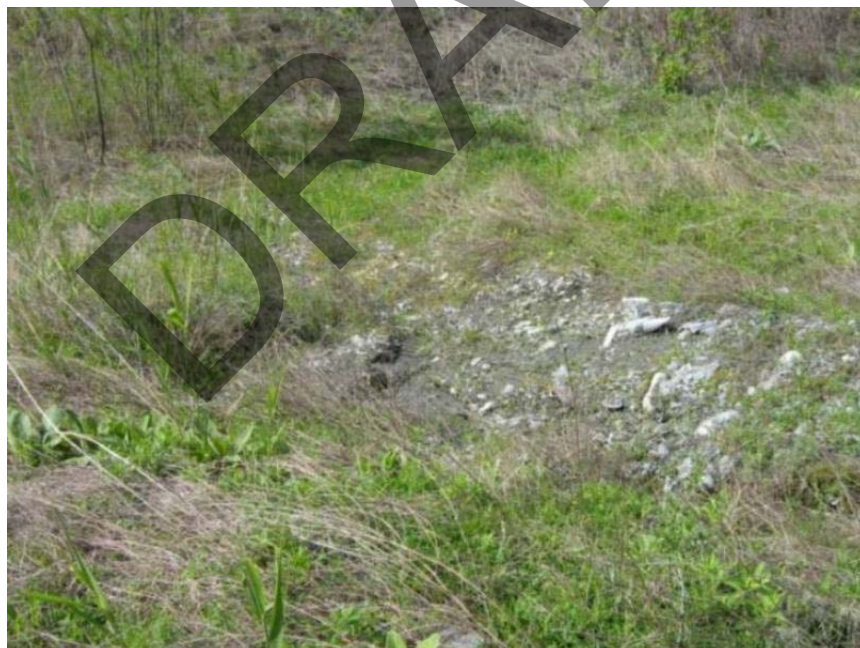
27. Ash Pond 2 - Surface Erosion along South Embankment Exterior Slope (Approximately 8' Width, 4' Deep, 30' Long)

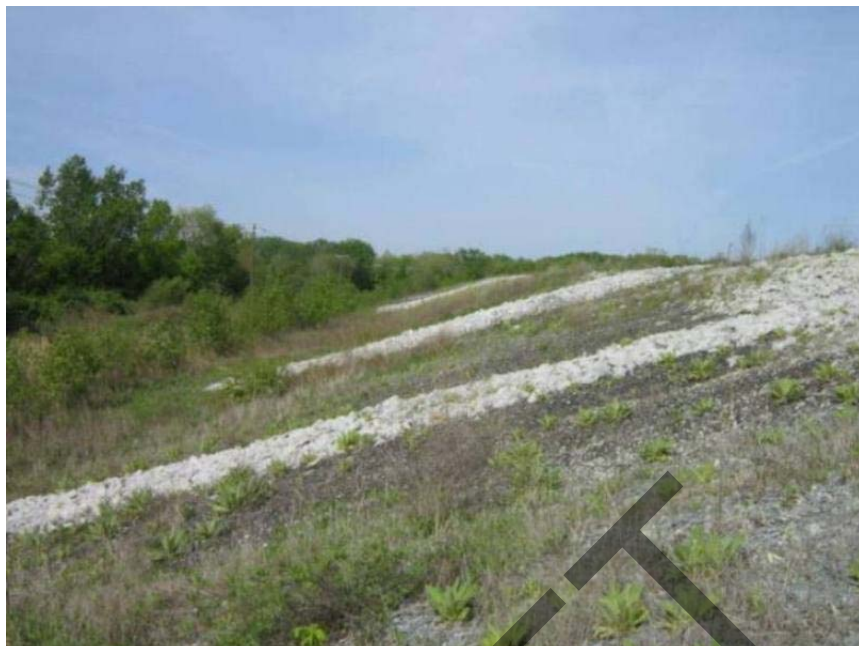
28. Ash Pond 2 - Riprap used to fill in Erosion Rills, South Embankment Exterior Slope, Looking West

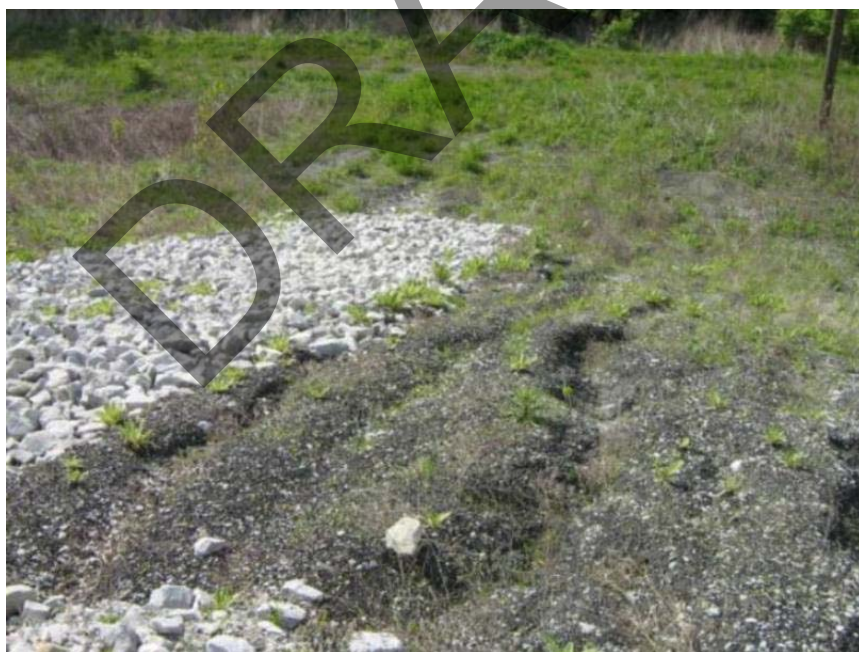
29. Ash Pond 2 - Erosion Rills Adjacent to Riprap on South Embankment Exterior Slope

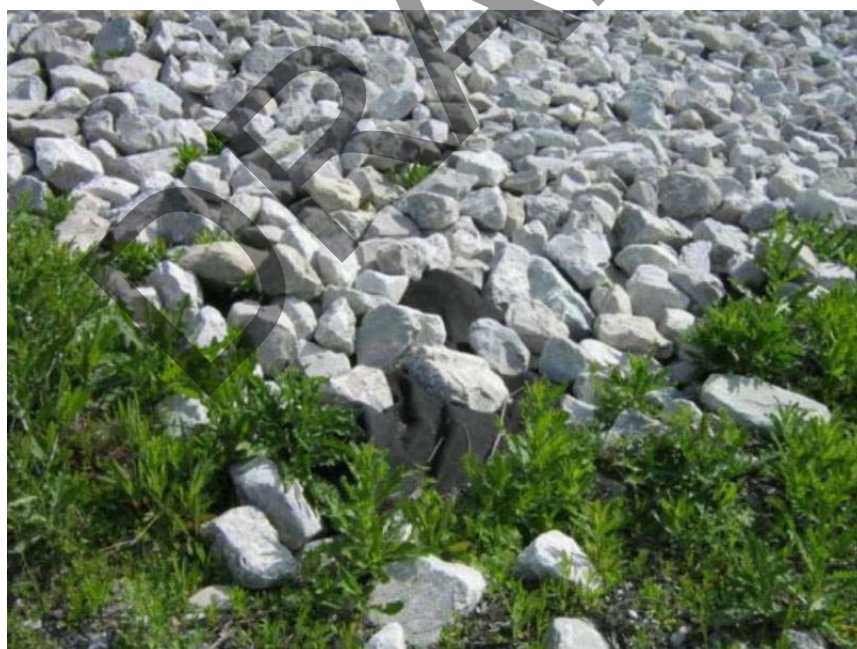
31. Ash Pond 2 - Filter Fabric under Riprap Layer. Filter Fabric is used when Erosion Rill Extended to Crest

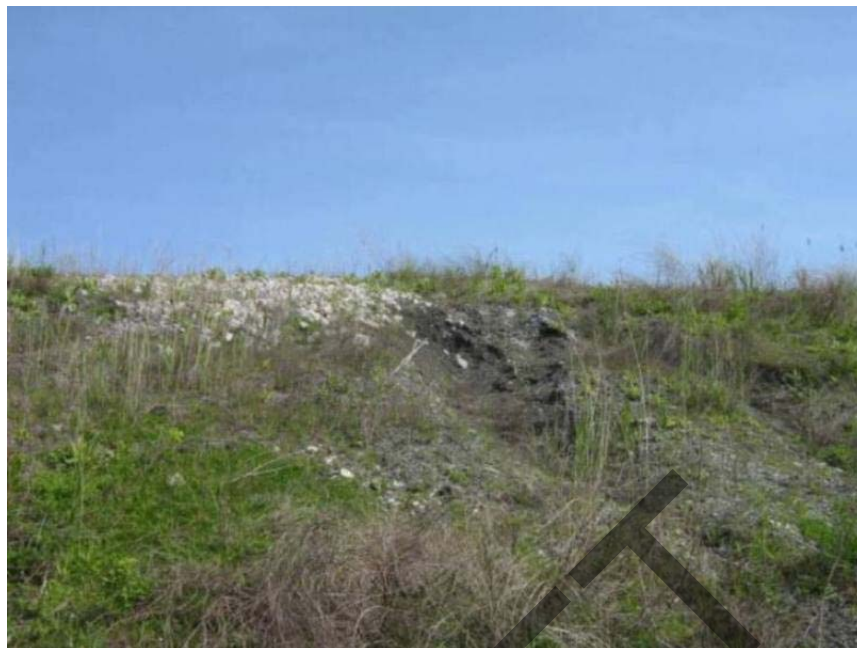
32. Ash Pond 2 - Surface Erosion below Riprap along South Embankment Exterior Slope

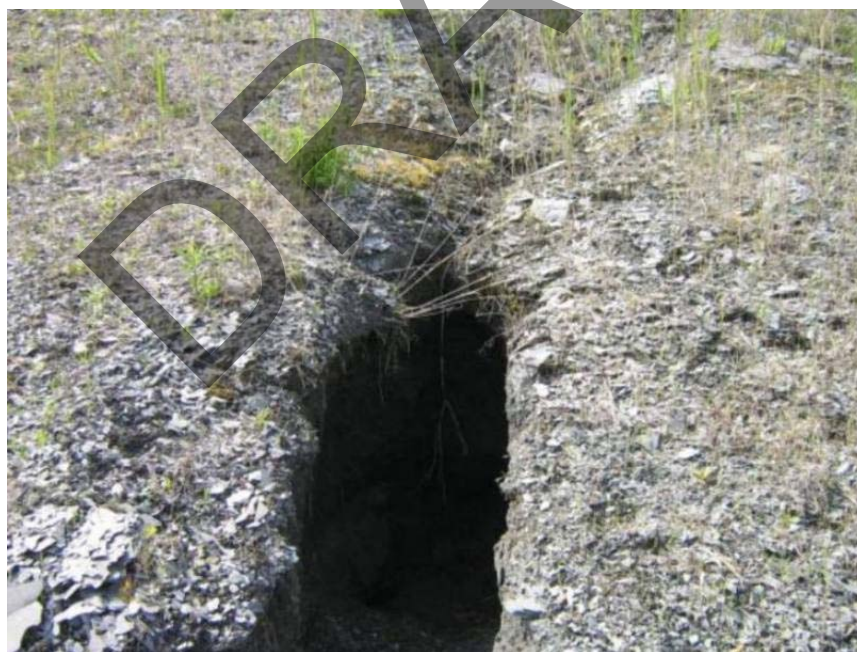
33. Ash Pond 2 - Deep Erosion Rill on South Embankment Interior Slope

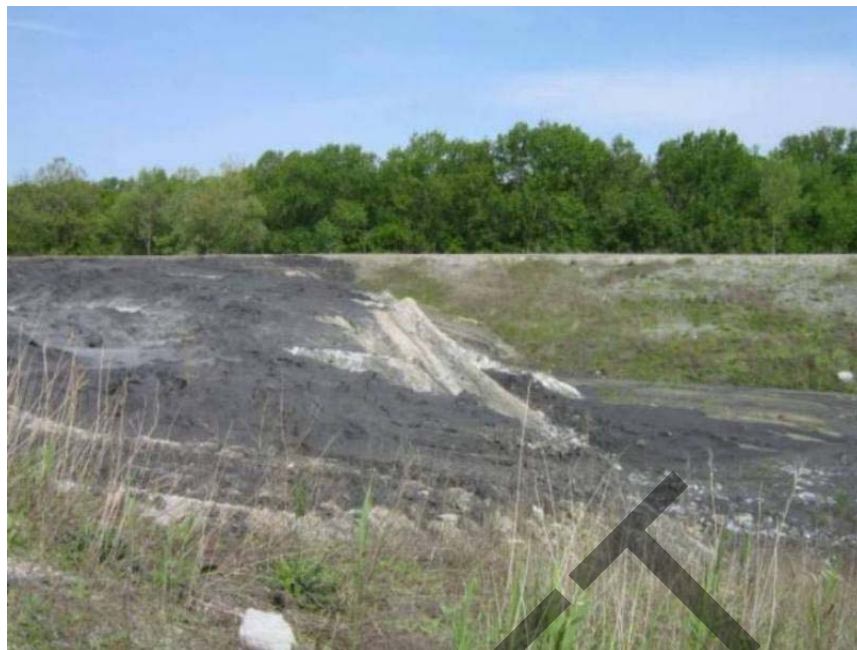
36. Ash Pond 2 - Dredging Spoil, West Embankment Interior Slope, Looking North

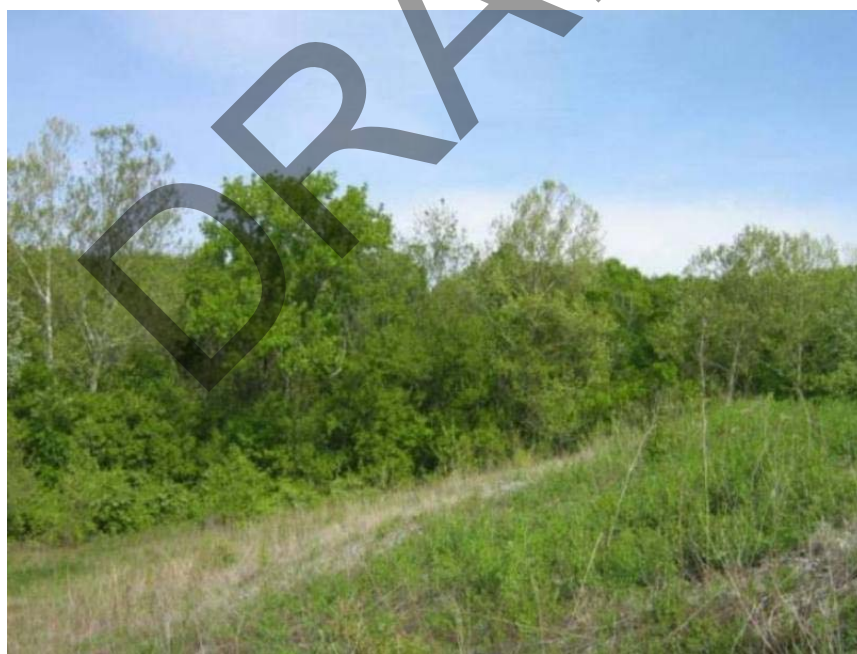
37. Ash Pond 2 - West Embankment Exterior Slope, Looking North  
(Slope is approximately 3H:1V)

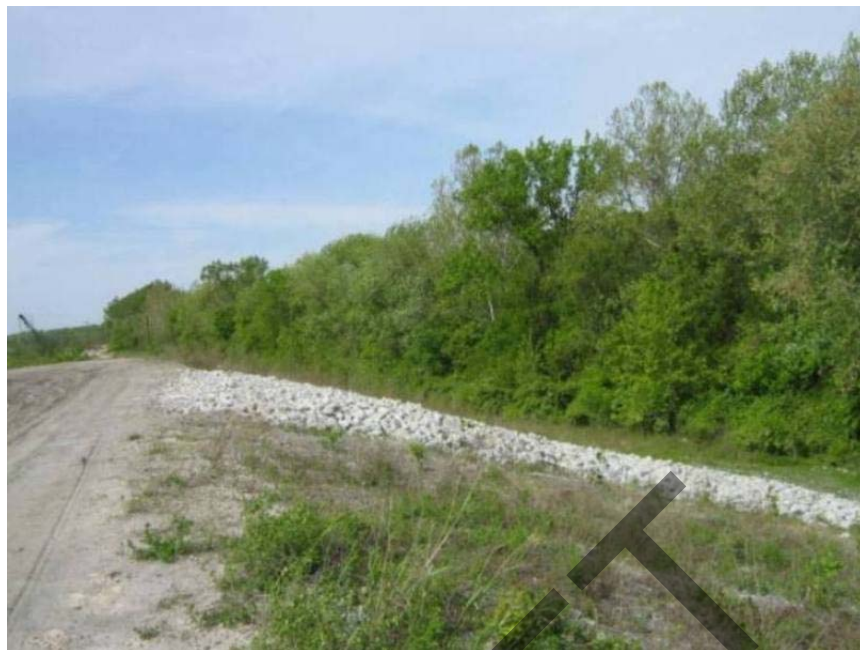
38. Ash Pond 2 - Northwest Embankment Exterior Slope, Looking West

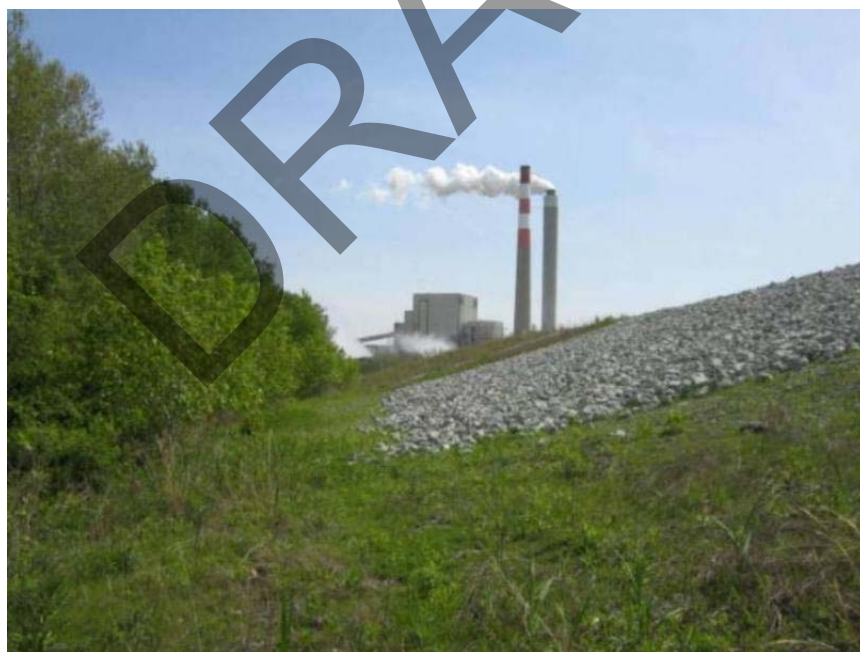
39. Ash Pond 2 - North Embankment Exterior Slope, Looking East

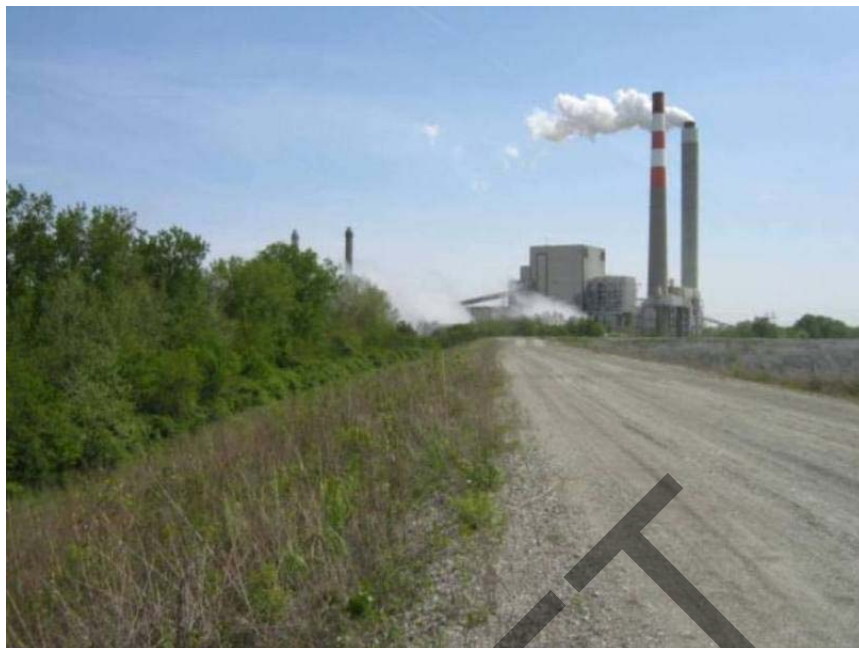
40. Ash Pond 2 - North Embankment Crest, Looking East,  
Established Vegetation on Exterior Slope

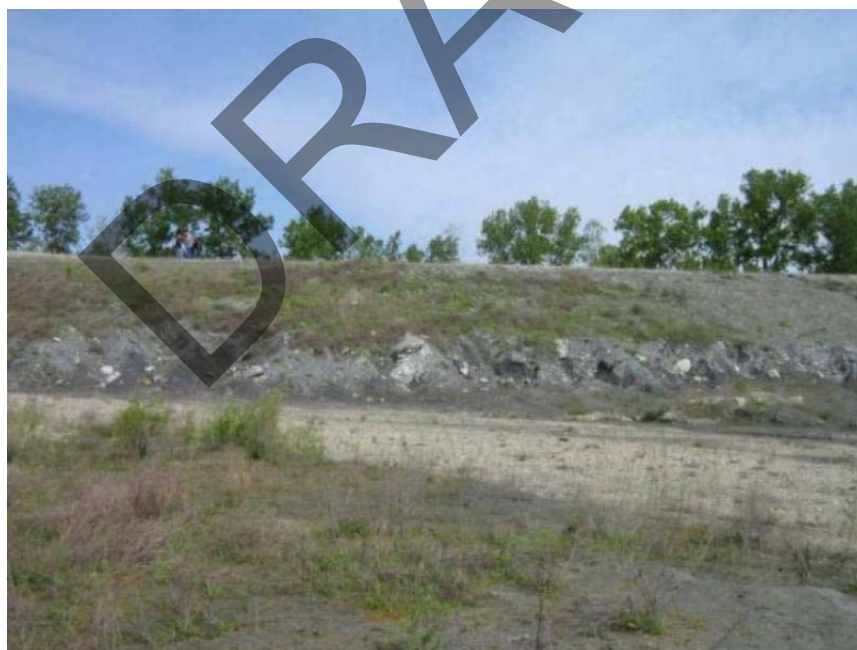
41. Ash Pond 2 - North Embankment Interior Slope, Looking North  
from Basin Floor

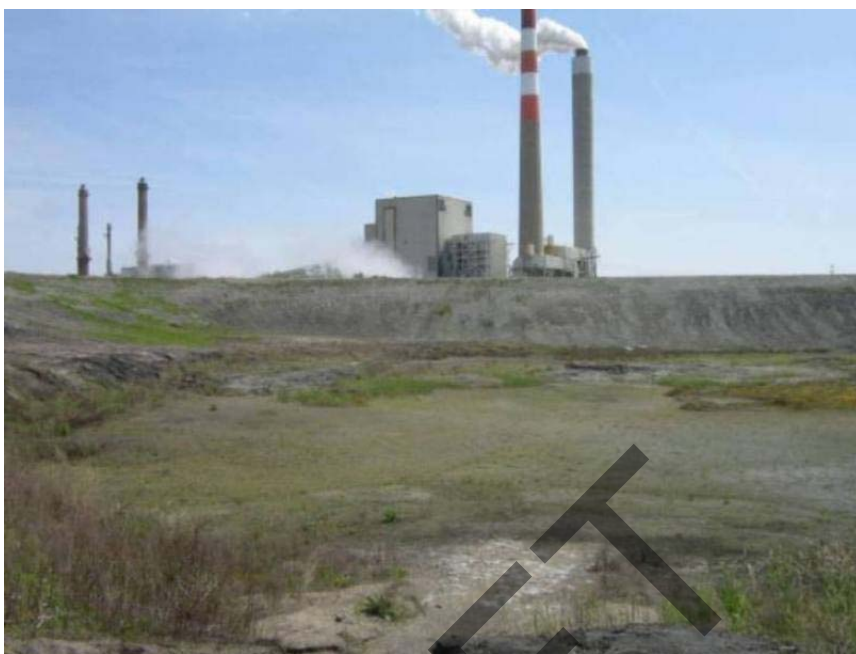
42. Ash Pond 2 - East Embankment Interior Slope, View from Basin Floor

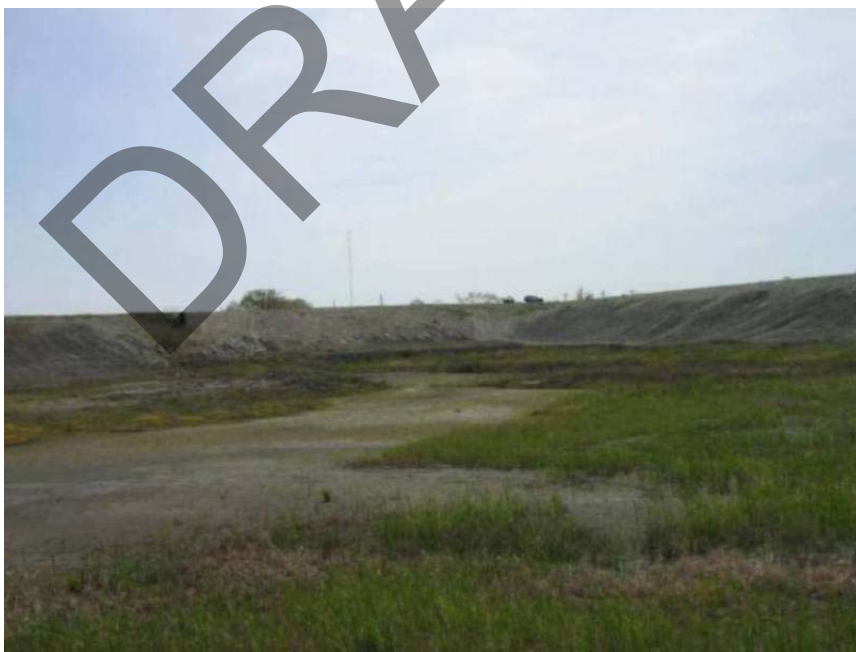
43. Ash Pond 2 - East Embankment Interior Slope, View from Basin

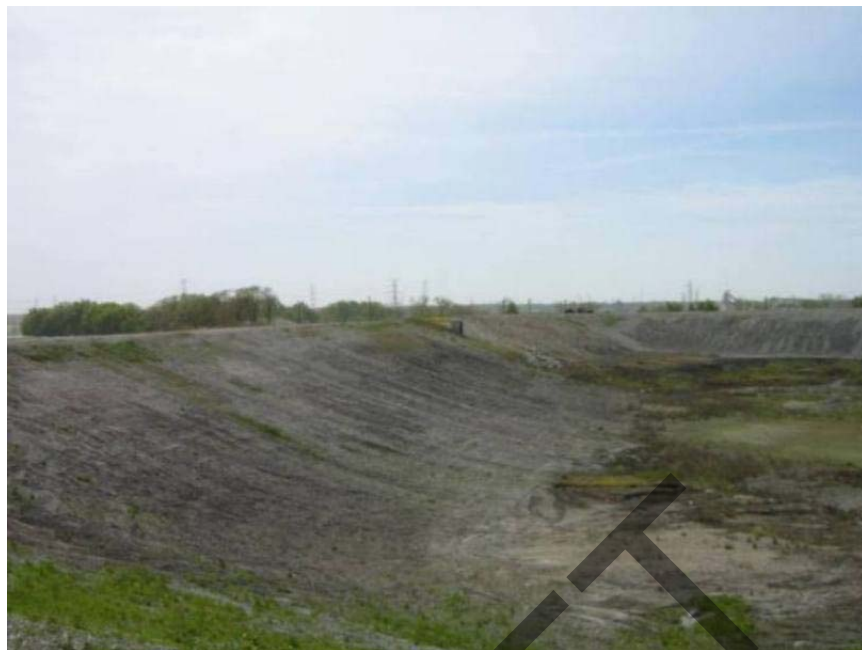
44. Ash Pond 2 - East Embankment Interior Slope, Looking South

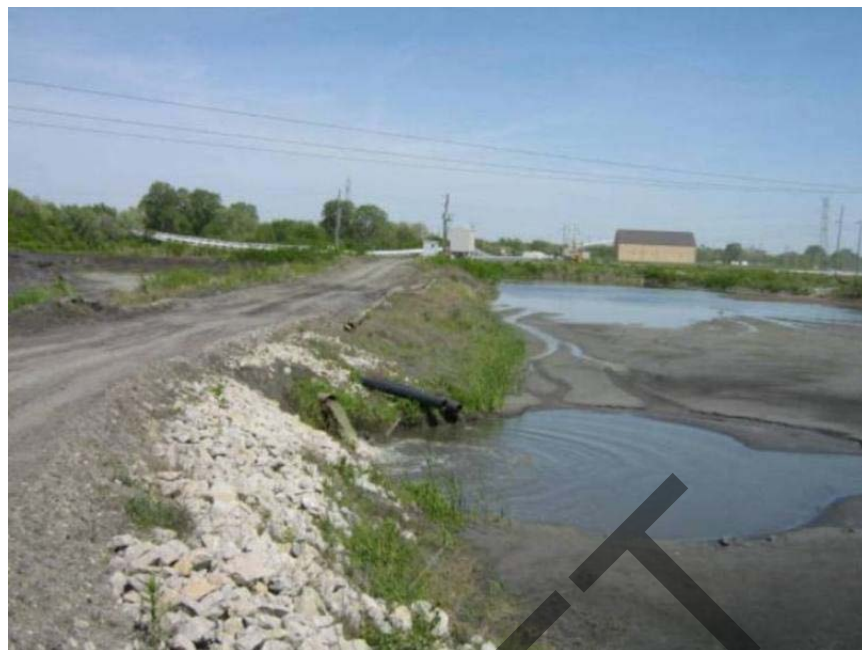
46. Ash Pond 2A - North Embankment Interior Slope, Looking East,  
Three (3) 8-inch-Diameter Outfall Pipes

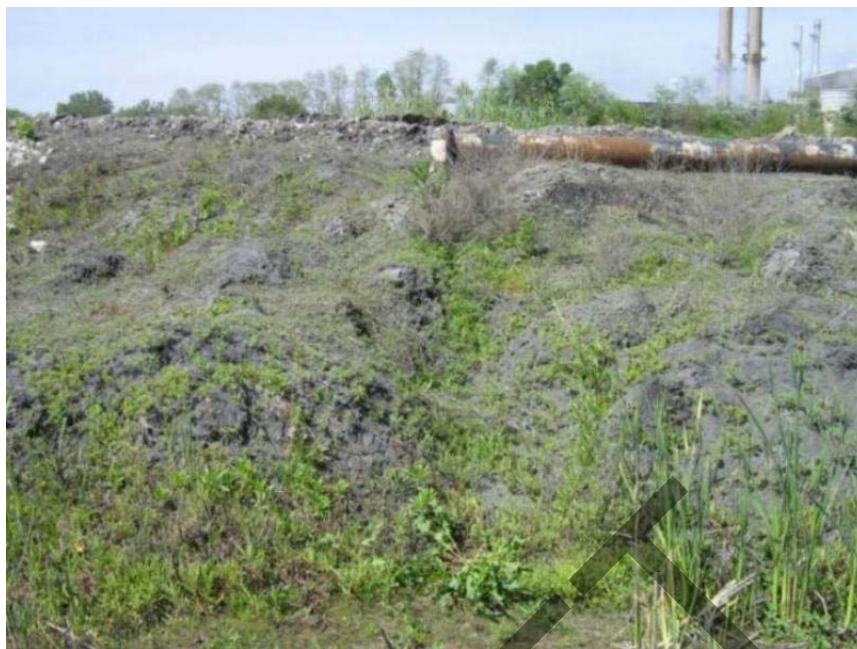
48. Ash Pond 2A - Erosion Rill along North Embankment Interior Slope, View from Pond (Approximately 1' Wide, 10' Long)

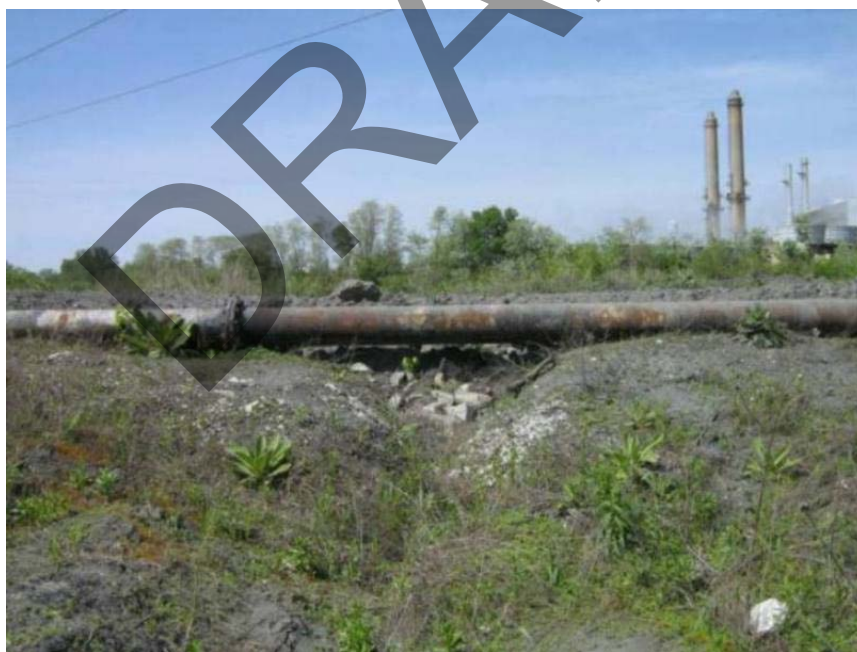
49. Ash Pond 2A - North Embankment Interior Slope, Erosion Rill Undercuts Active Sluice Lines

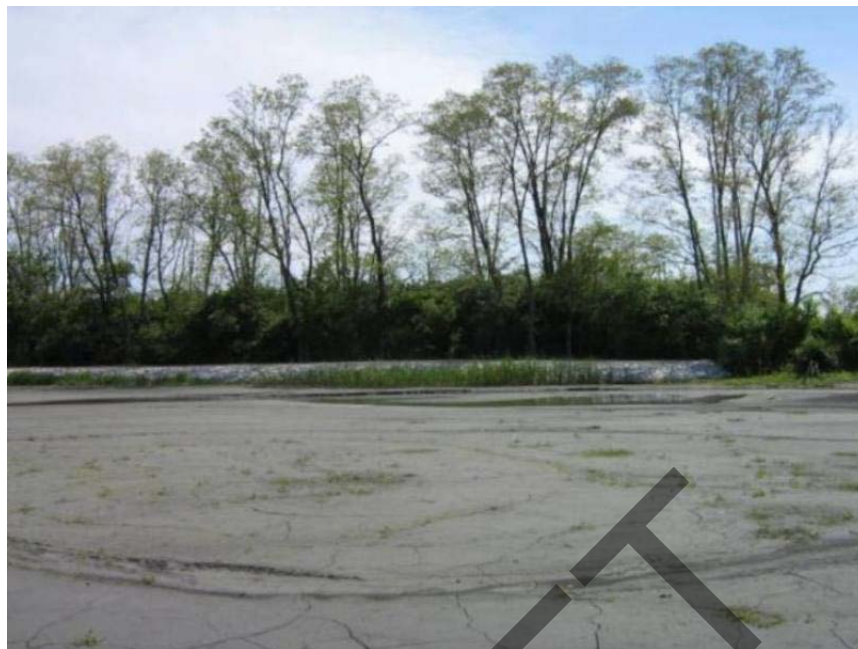
50. Ash Pond 2A - Vegetation along South Embankment Interior Slope, Looking South
